# COTTAGE HILL INSPECTIONS, INC.

Thank you for the opportunity to inspect the property located at **600 E. Any Street, Arlington Heights, Illinois** on January 29, 2020.

**606 E. ANY STREET**

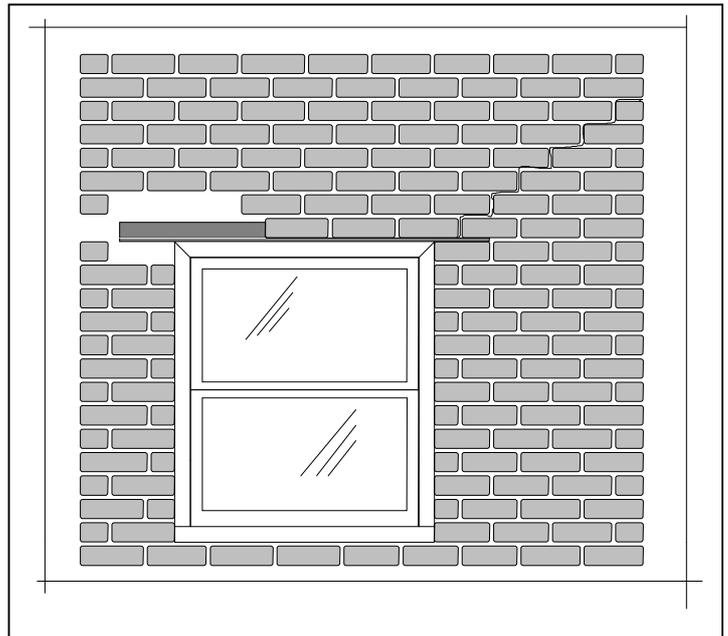
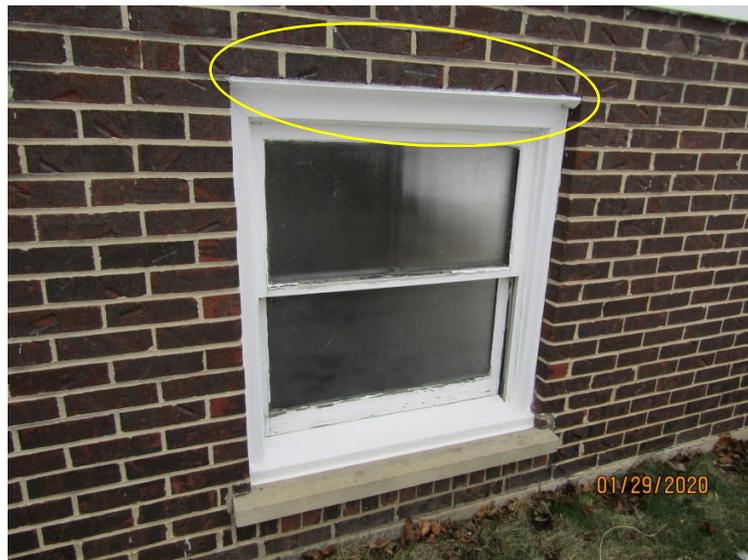
**WINDOW AND LINTEL CONDITION**

- The attached photographs show the condition of the window and lintel condition.

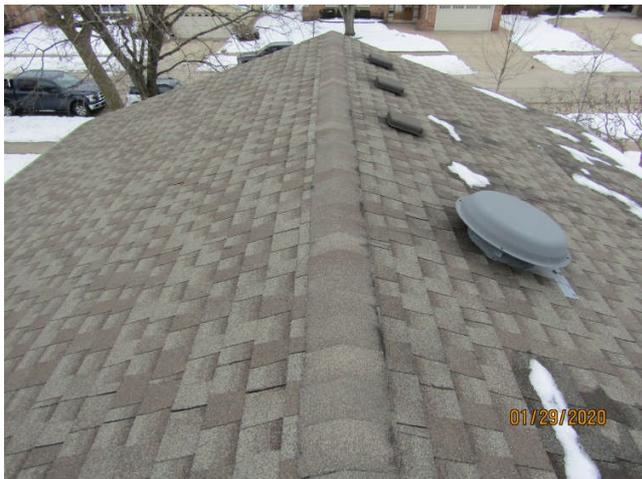
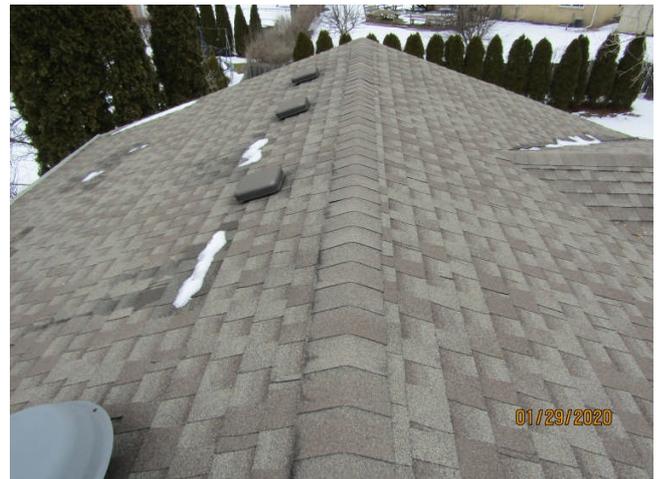
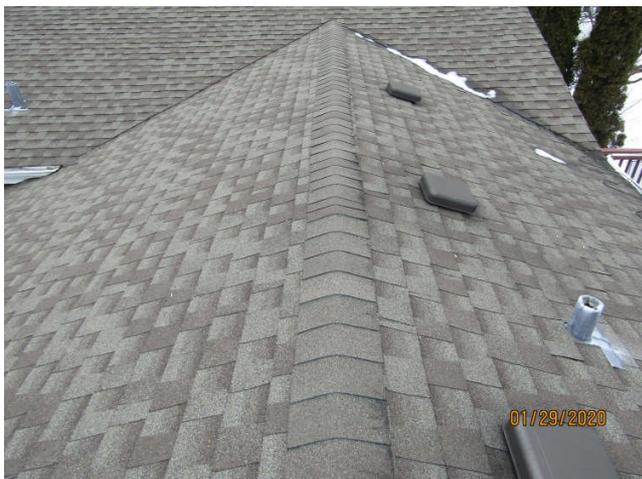
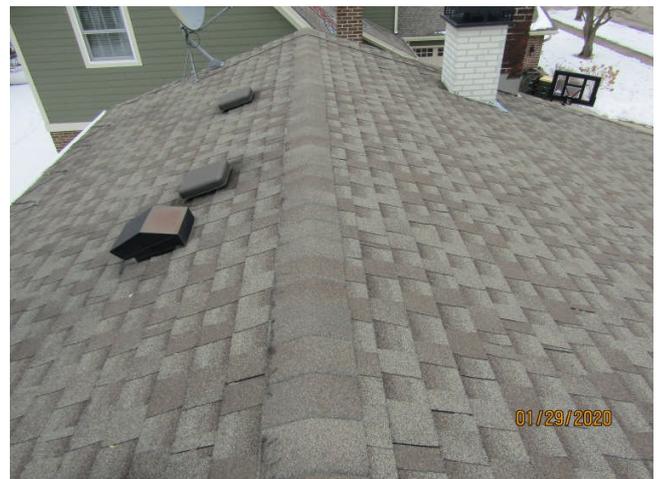
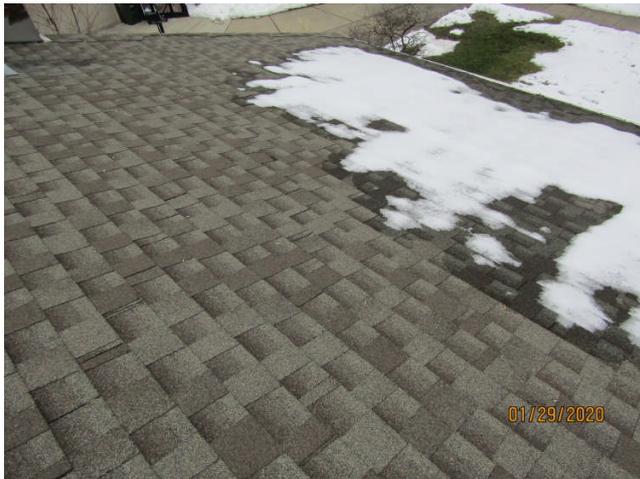
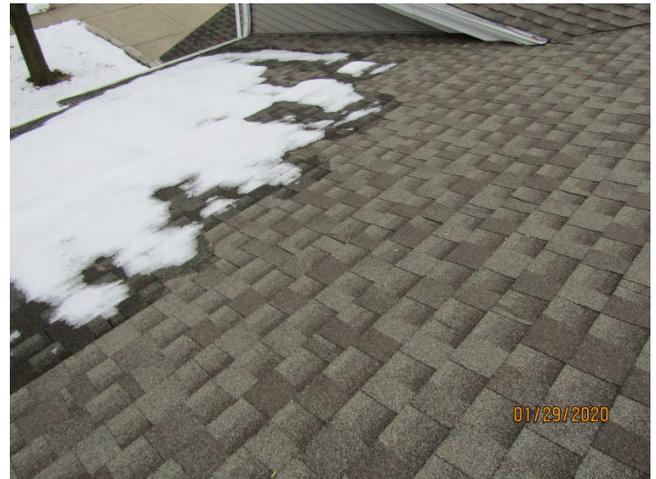
### ROOF SURFACE CONDITION

- Warped, curled or cupped shingles are an early indication of a roof surface in decline.
- Loss of the colored mineral granules on the shingles is an indication of a roof surface in rapid decline.
- It is recommended that the existing layers of shingles be removed before a new roof surface is installed.
- There are no signs of active roof leaks.
- The attached photographs show the condition of the roof surface.

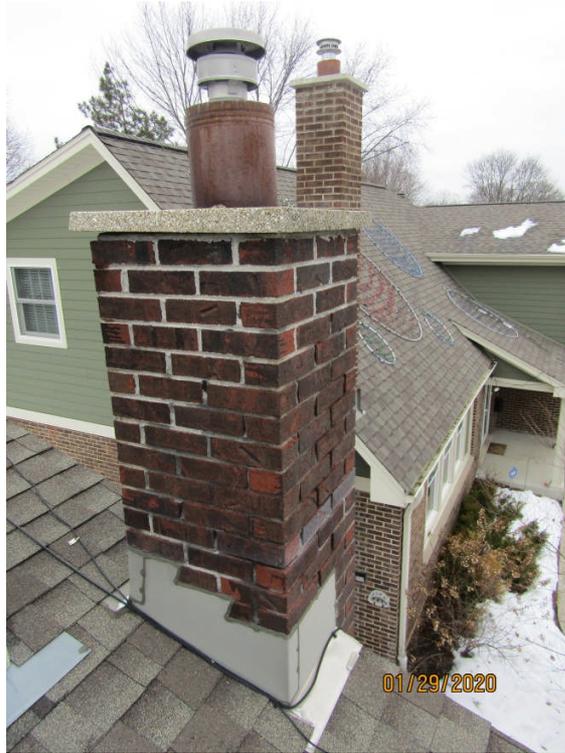
#### **CHIMNEY CONDITION**

- There are areas where the mortar between the bricks on the chimney has deteriorated. This condition can permit rain and ice to penetrate the chimney wall causing leaks, hidden damage inside or further deterioration outside. The repair of this condition ["tuck pointing"] is recommended before additional damage can occur. This condition has been discussed with the client.
- The attached photograph shows the condition of the chimney.

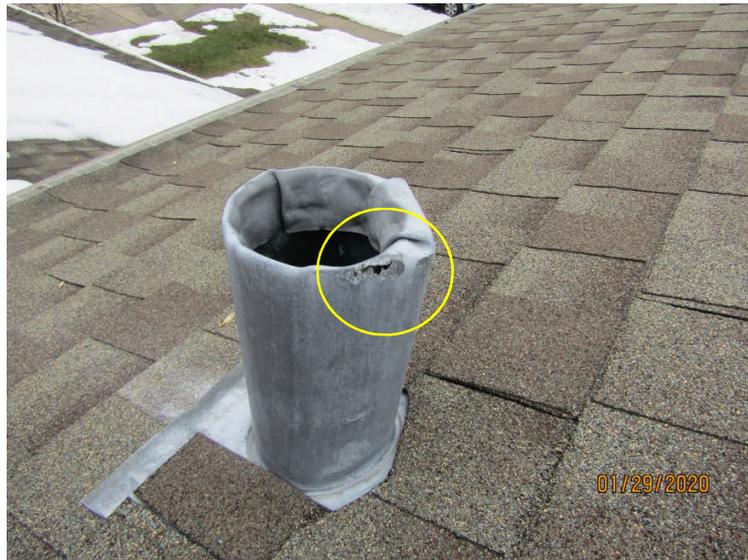
**PIPE FLASHING CONDITION**

- There is a hole in the lead flashing for one of the plumbing vent pipe. It is recommended that this condition be corrected by repair or replacement. The attached photograph shows this condition.

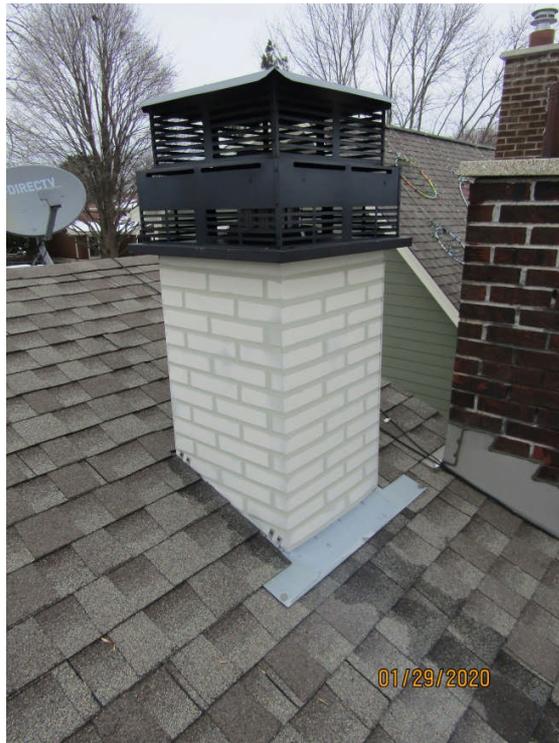
**METAL FIREPLACE FLUE CONDITION**

- The attached photograph shows the condition of the metal fireplace vent.

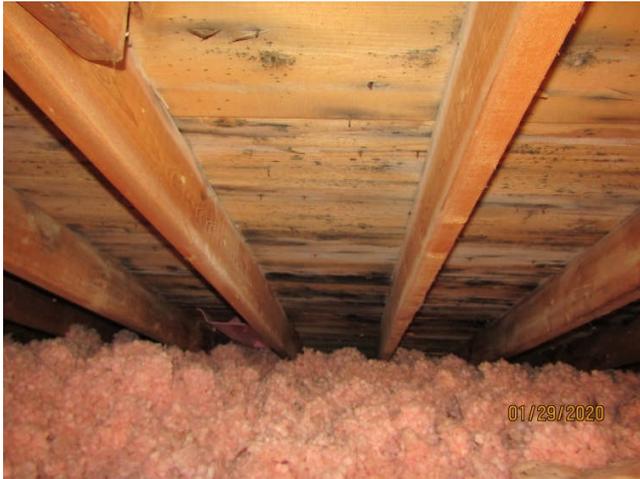
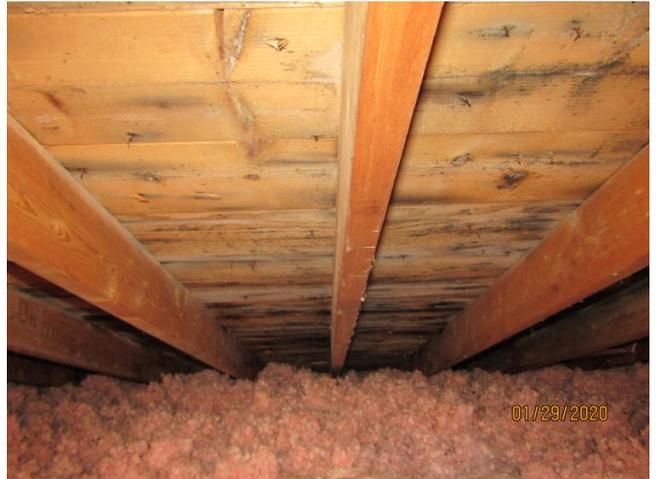
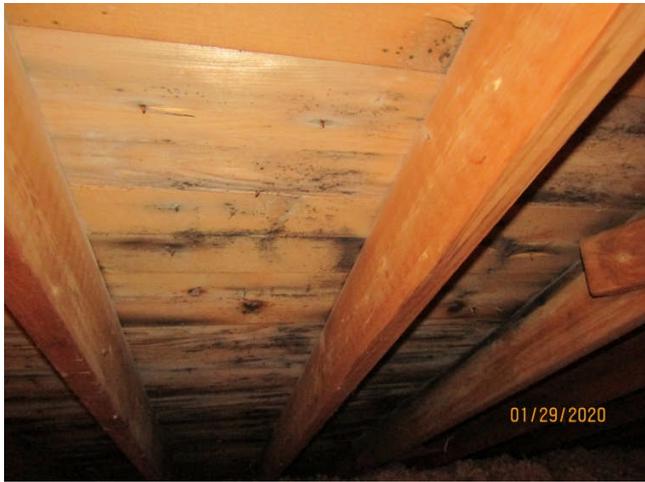
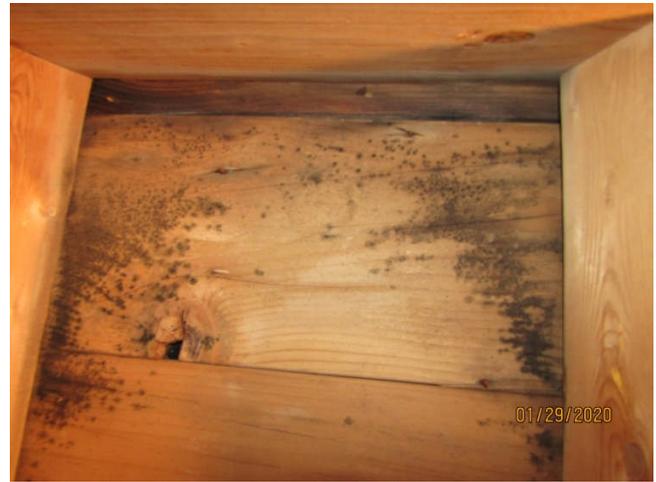
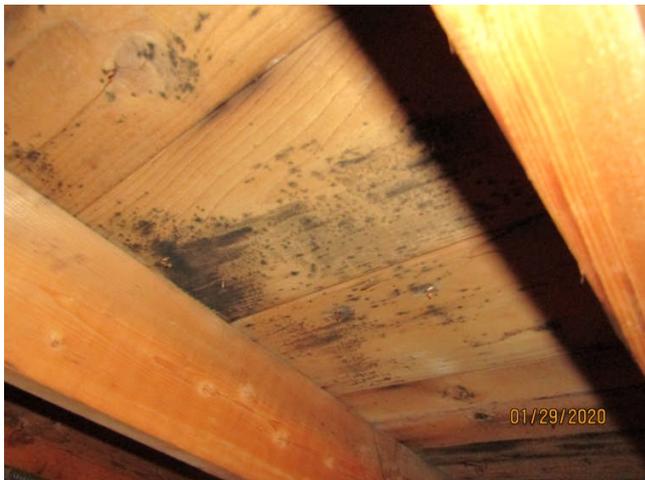
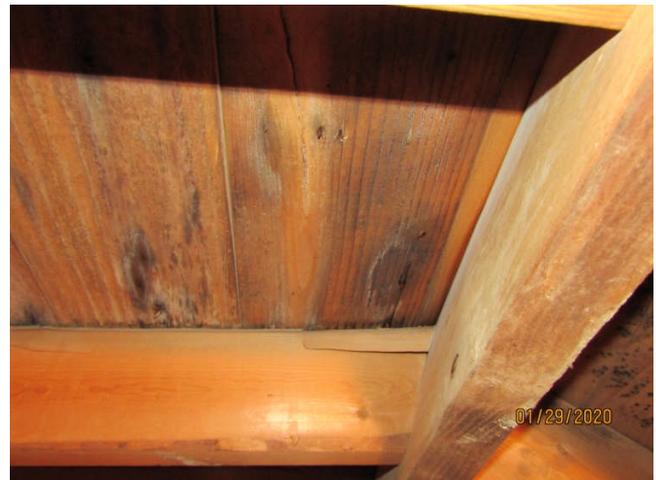
**ROOF SHEATHING CONDITION**

- There is a mold like substance on the roof sheathing material in the attic that may be toxic to some individuals. The moisture content of several areas were tested [with the **Protimeter Surveymaster SM** moisture detector] and found to be dry at this time. It is recommended that this condition be evaluated by a remediation specialist because the cause of the moisture causing this condition could not be determined and there is a possibility that the substance may become active in certain humid conditions. This condition has been discussed with the client. The attached photographs show this condition.

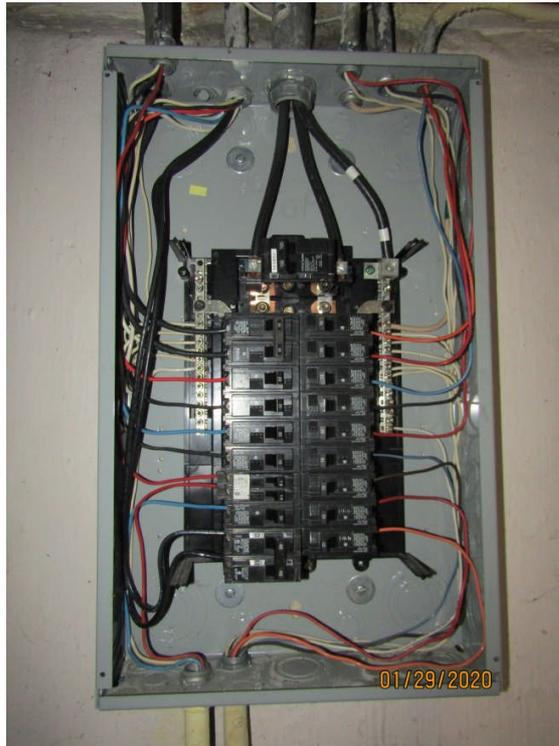
#### ELECTRICAL DISTRIBUTION PANEL CONDITION

- The cable that completes the electrical "grounding" connection around the water meter on the water supply pipe is not installed. This *can* be a dangerous condition. The prompt correction and documentation of the correction by a qualified professional electrician is recommended to insure safe operation.

- The electrical distribution panel has a "tandem" type circuit breaker installed. This type of circuit breaker is not permitted in this panel by the manufacturer. This condition could make an improper physical connection in the panel which can create a fire hazard and can damage the bus bar, which cannot be repaired. Replacement of the panel would be necessary. The prompt correction and documentation of the correction by a qualified professional electrician is recommended to insure safe operation. This condition has been discussed with the client.

- The attached photograph shows the condition of the electrical distribution panel.

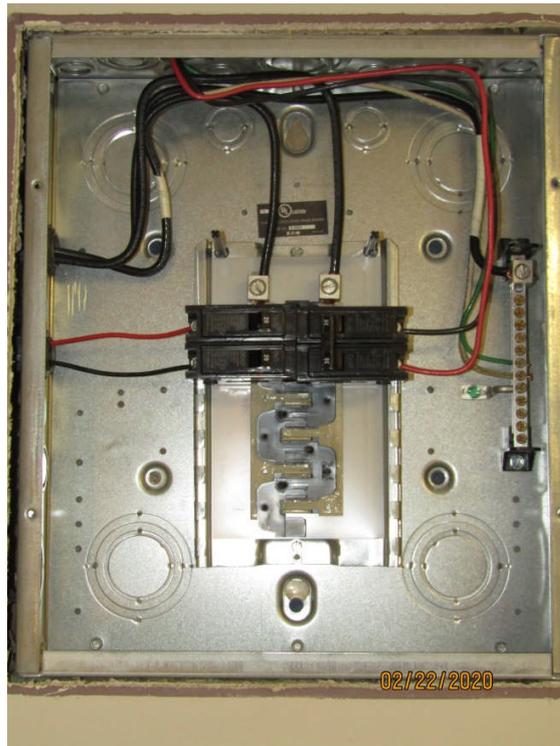
### ELECTRICAL DISTRIBUTION SUB- PANEL CONDITION

- The electrical distribution sub- panel has a “bonding” connection from the neutral bus bar to the panel cabinet. This *can* be a dangerous condition. Generally, the grounded conductor (neutral) is permitted to be bonded to the grounding conductor only at the main service disconnect, typically located 5- 10 feet from the point of entrance to the building. The prompt correction and documentation of the correction by a qualified, professional electrician is recommended to insure safe operation.
- The attached photograph shows the condition of the electrical distribution sub- panel.

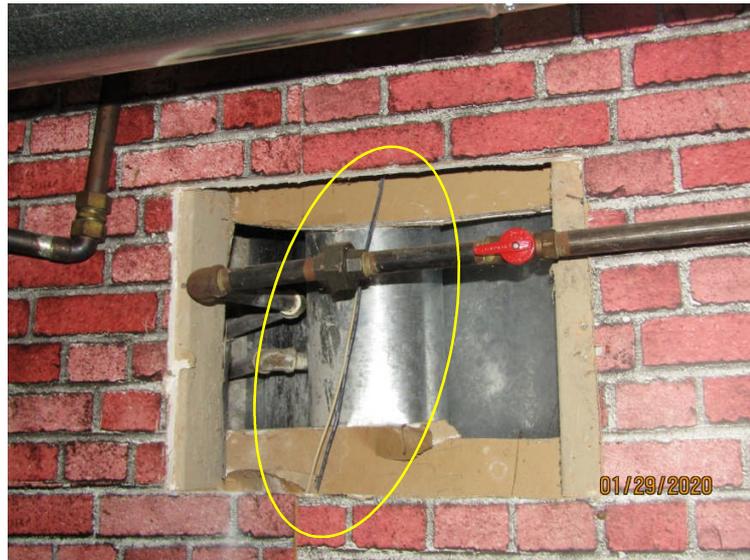
**BRANCH WIRING CONDITION**

- There is exposed wiring in the basement that may become live under certain conditions. The purpose of this wiring could not be determined. Exposed high voltage wiring **can** be a dangerous condition. It is recommended that this condition be evaluated and corrected by a qualified electrical contractor to insure safe operation. The attached photograph shows this condition.

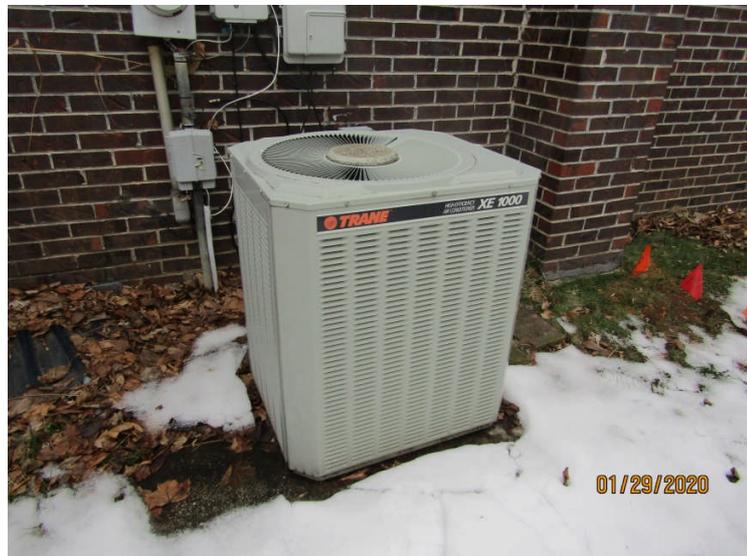
- The attached photograph shows the location of the air conditioning compressor/ condenser unit.

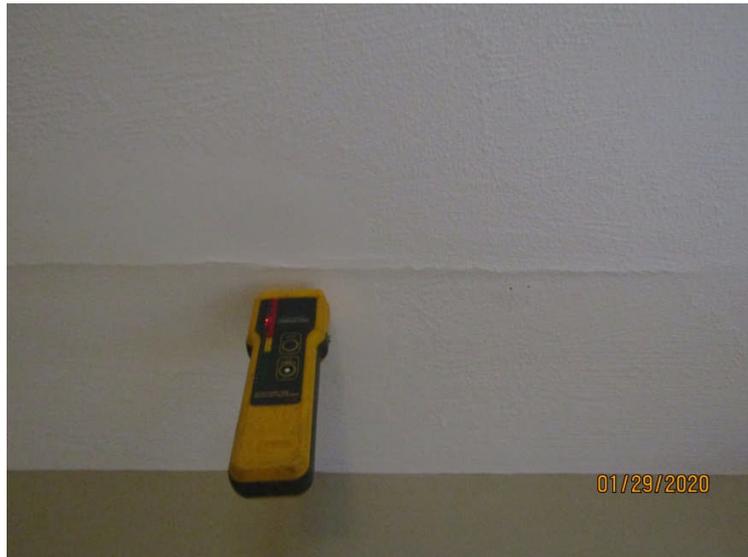
#### DRYWALL CONDITION

- Much of the door hardware has been painted in the process of decorating, limiting its function.
- In the absence of functional defects we suggest that these interior surfaces be evaluated by the client on the basis of appearance.
- There is an area of drywall in the living room ceiling that is water stained. The moisture content of this area was tested [with the **Protimeter Surveymaster SM** moisture detector] and found to be damp at this time. The exact cause of this moisture could not be determined and the extent of any moisture damage behind the drywall cannot be determined in a non-invasive home inspection. It is recommended that this condition be corrected by a qualified contractor. This condition has been discussed with the client. The attached photographs show this condition.
