# COTTAGE HILL INSPECTIONS, INC.

Thank you for the opportunity to inspect the property located at **600 E. Any Street, Arlington Heights, Illinois** on January 29, 2020.

**606 E. ANY STREET**

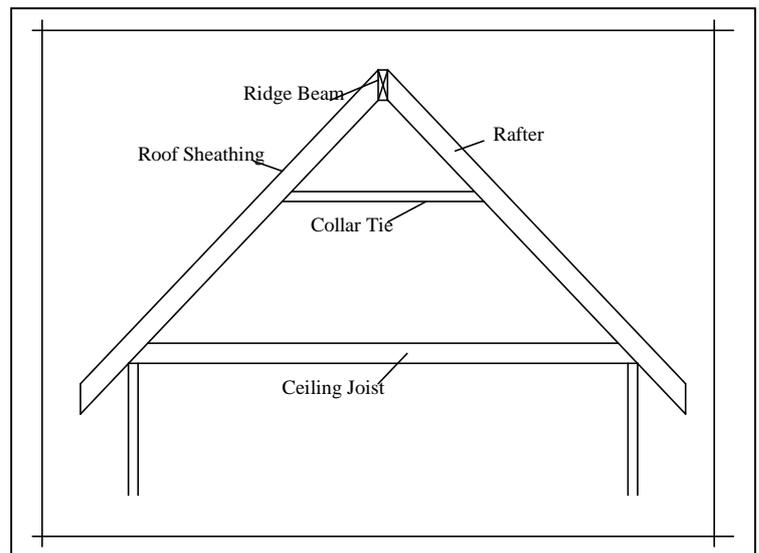
**ROOF FRAMING CONDITION:** functional, except for the condition recommended for correction below

- There is a mold like substance on the roof sheathing material in the attic that may be toxic to some individuals. The moisture content of several areas were tested [with the **Protimeter Surveymaster SM** moisture detector] and found to be dry at this time. It is recommended that this condition be evaluated by a remediation specialist because the cause of the moisture causing this condition could not be determined and there is a possibility that the substance may become active in certain humid conditions. This condition has been discussed with the client. The attached photographs show this condition.

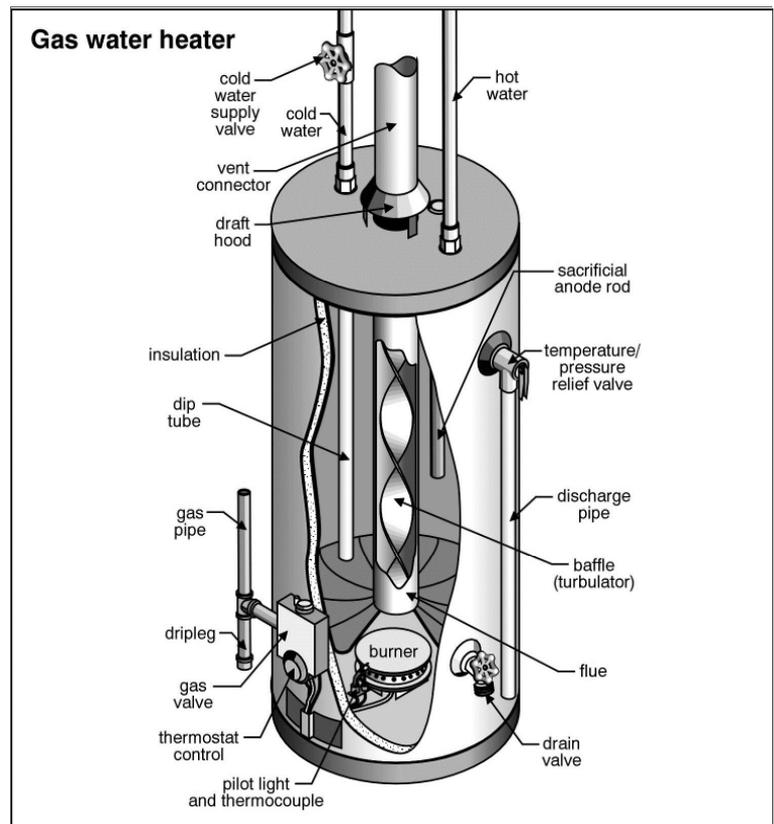
- The water heater combustion gases were tested for carbon monoxide with the **Bacharach Monoxer Plus** carbon monoxide analyzer [calibrated 8 January, 2019]. The carbon monoxide level of the water heater combustion gases was found to be less than 100 parts per million. Carbon monoxide levels over 100 parts per million in combustion gases are an indication of incomplete combustion and represent a potentially dangerous condition.

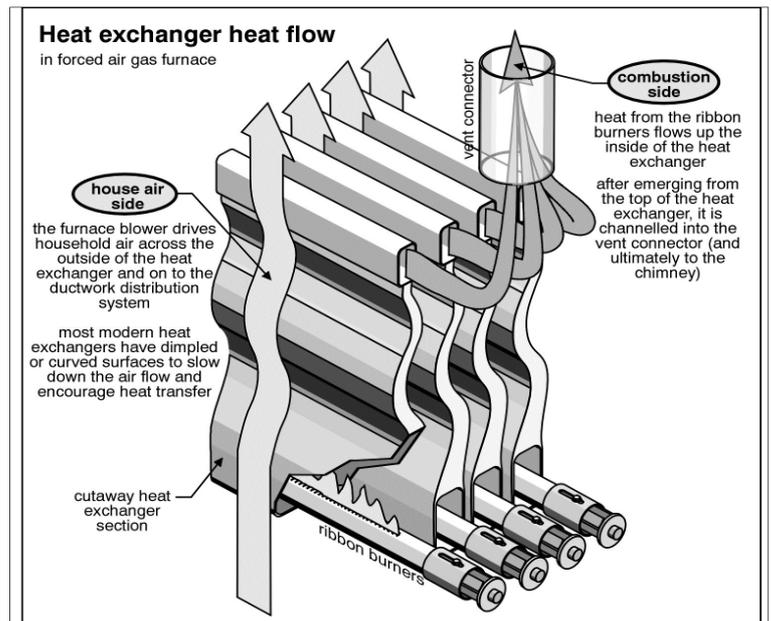
- The plenum [warm air duct] was tested for carbon monoxide with the **Bacharach Monoxer Plus** carbon monoxide analyzer [calibrated 8 January, 2019]. The carbon monoxide level was found to be near zero parts per million.
- The useful life of this type of furnace is typically from twenty to twenty-five years.
- It is recommended that furnaces be inspected and serviced by a competent heating contractor at the start of each heating season.
- The client has been shown how to change furnace filters.

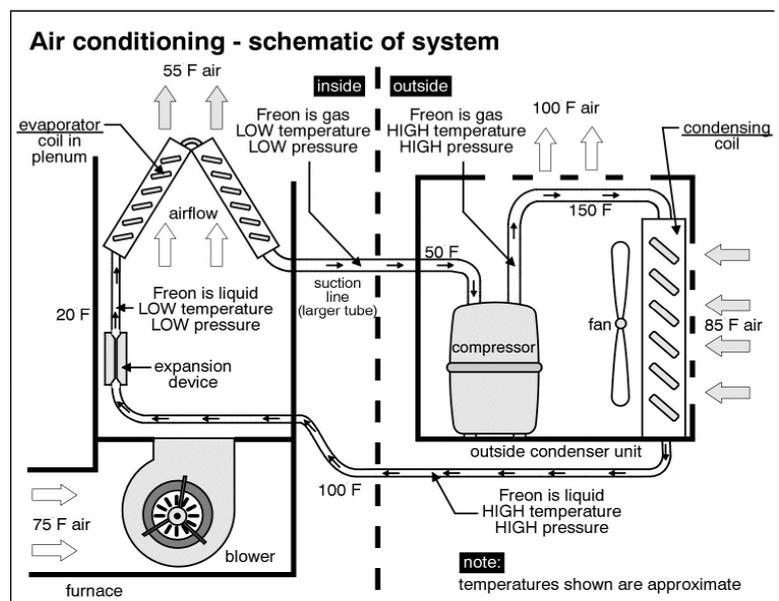
**CENTRAL AIR CONDITIONING CONDITION:** undetermined

- Testing central air conditioning in temperatures below 65° can result in damage to the system. Since this system could not be tested as part of this home inspection it is recommended that the client have a rider attached to the purchase contract extending the inspection contingency for the central air conditioning system until the outside air temperature reaches 65° and the system can be safely tested.
